### 3.14 Silverlake Recreation Center Swimming Pool

### 3.15 Marriot Beach Club Swimming Pool

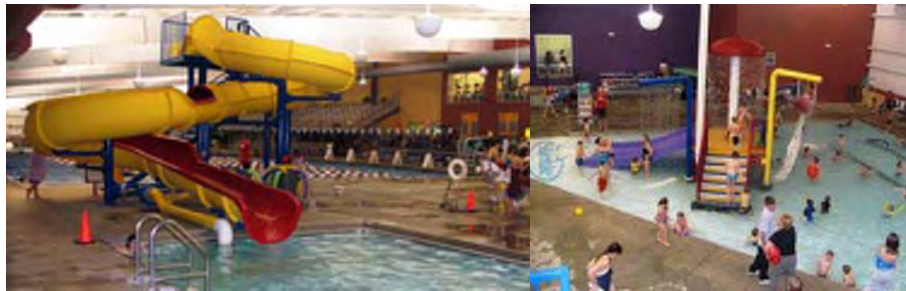
**Figure 3.16:** Images of Silverlake swimming pool, which achieved a reduction in backwash of 80% using two *AquaKLEAR* units.

The results of the test are shown very clearly on page 2 of the report in the form of savings. For instance, the duration of each backwash was reduced from 5 mins to 1 min, leading to a **reduction of the total backwash and sewage costs of 80%**.

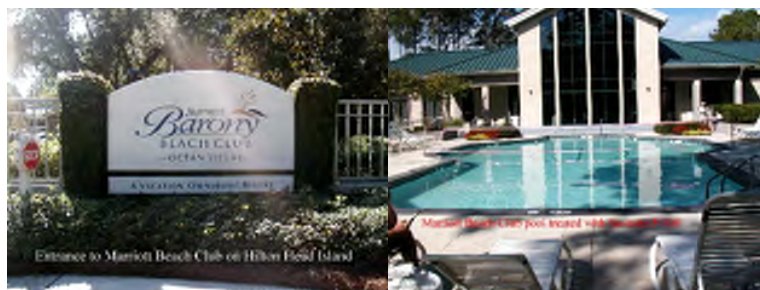
**Figure 3.17:** Images of Marriot Beach Club swimming pool, which before treatment with *AquaKLEAR* was known as the “ghost pool” due the cloudy water. The water was completely cleared after three days treatment with *AquaKLEAR*.

- After 3 days, the pool was clear for the first time.
- The grout lines on the tiled pool floor could be seen.
- After 5 days, the auto-chemicals were re-adjusted.
- After 7 days, there was still no sign that a backwash was necessary.
- The pool previously required backwashing once per day.

Treatment with *AquaKLEAR* meant that the chemical use could be reduced by about a half, and the backwashing was reduced by 75%.
